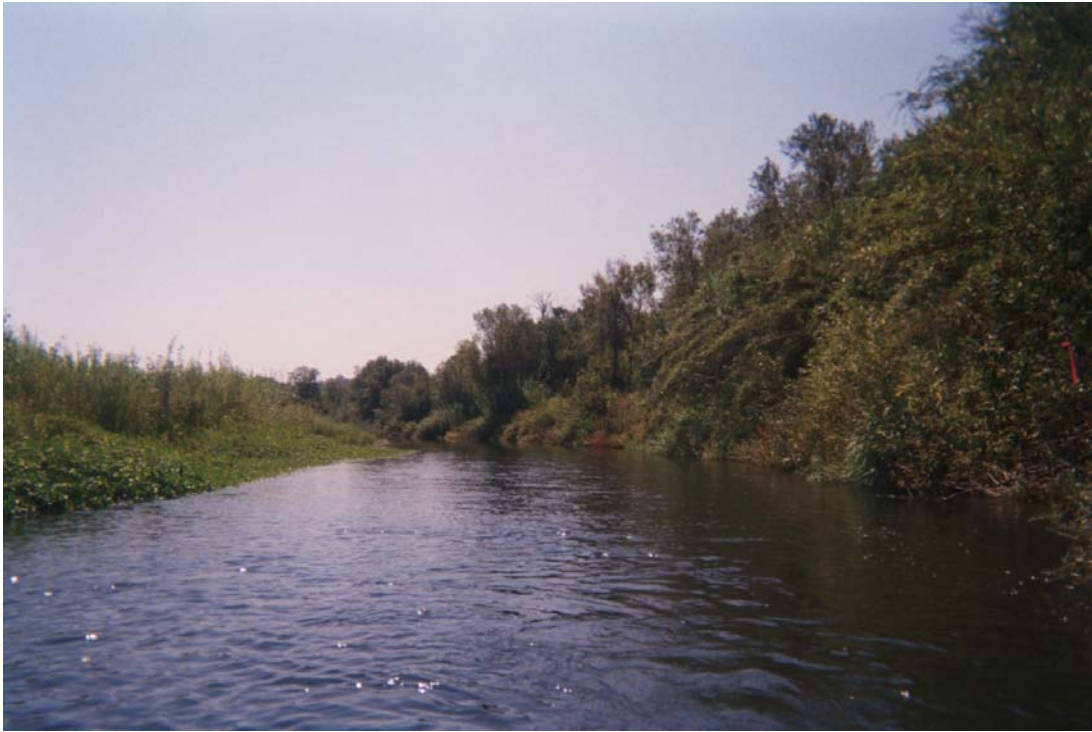
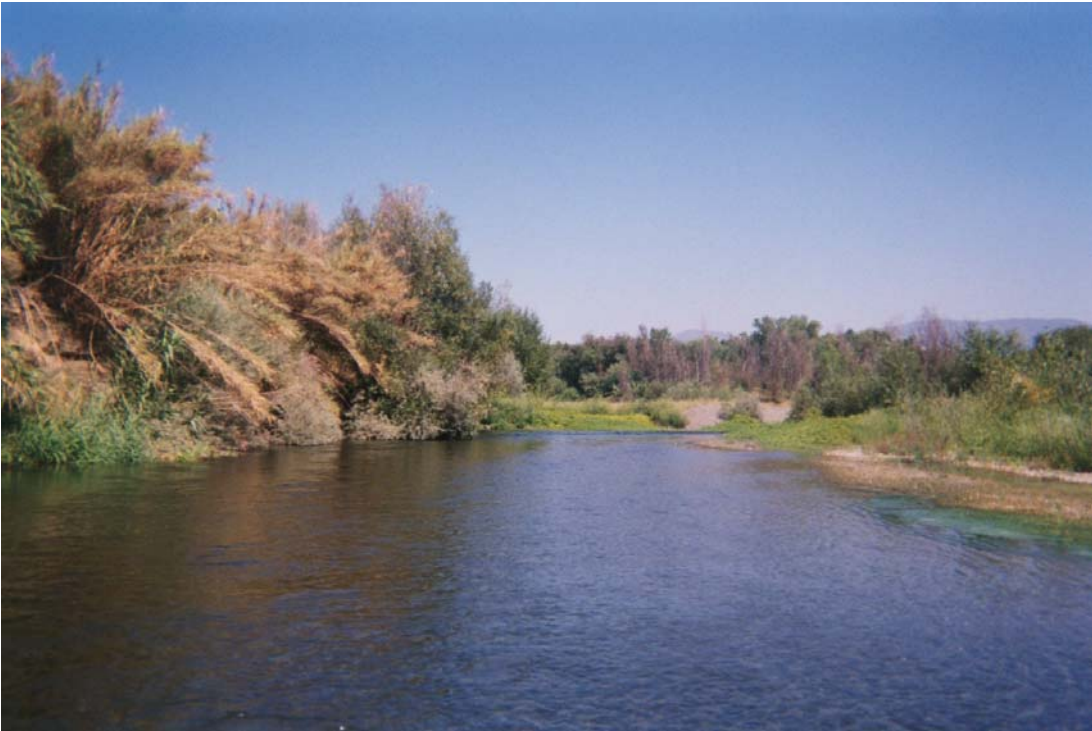
Figure 37: Alexander Valley Reach, Segment A11. This segment was dominated by flatwater (92%) with occasional shallow riffles (5%) and deep pools (3%). No steelhead were observed.

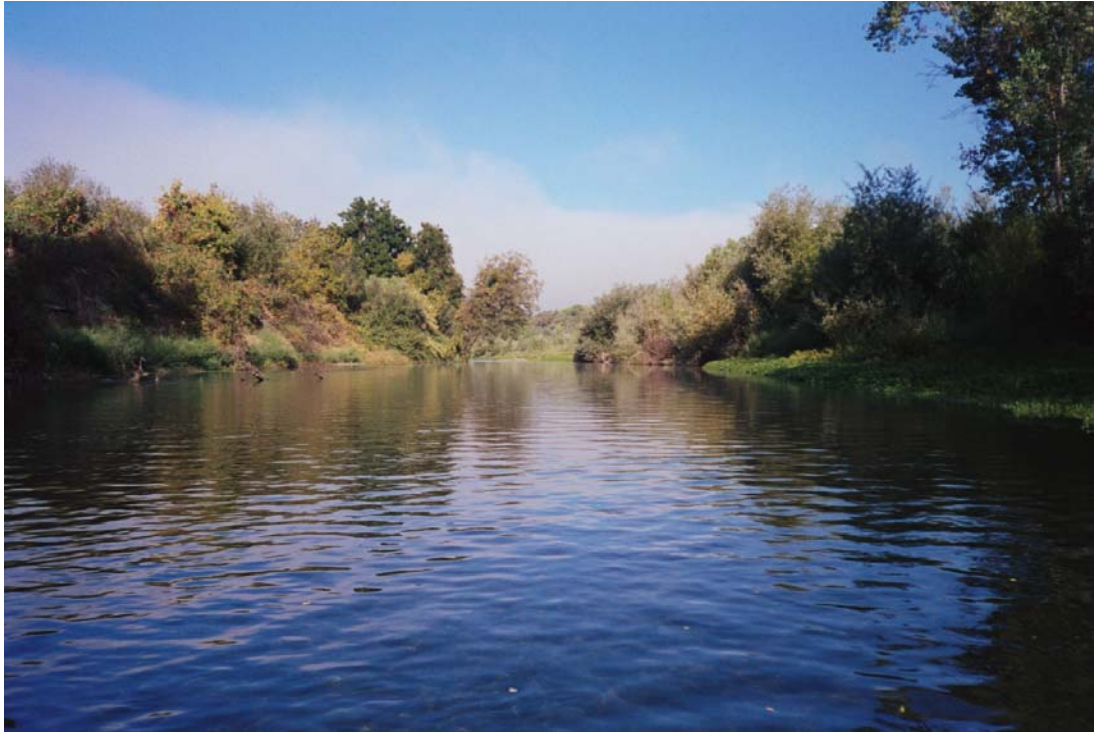
Figure 38: Healdsburg Reach, Segment H1. This segment was not dive surveyed but contained primarily flatwater habitat.

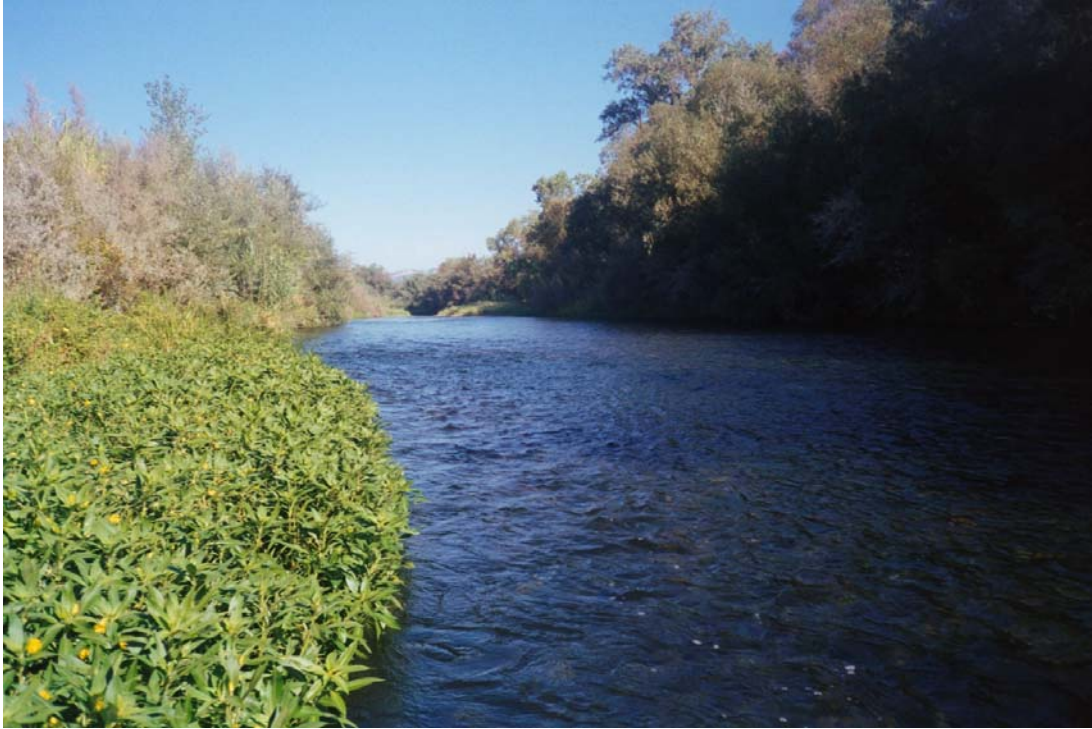
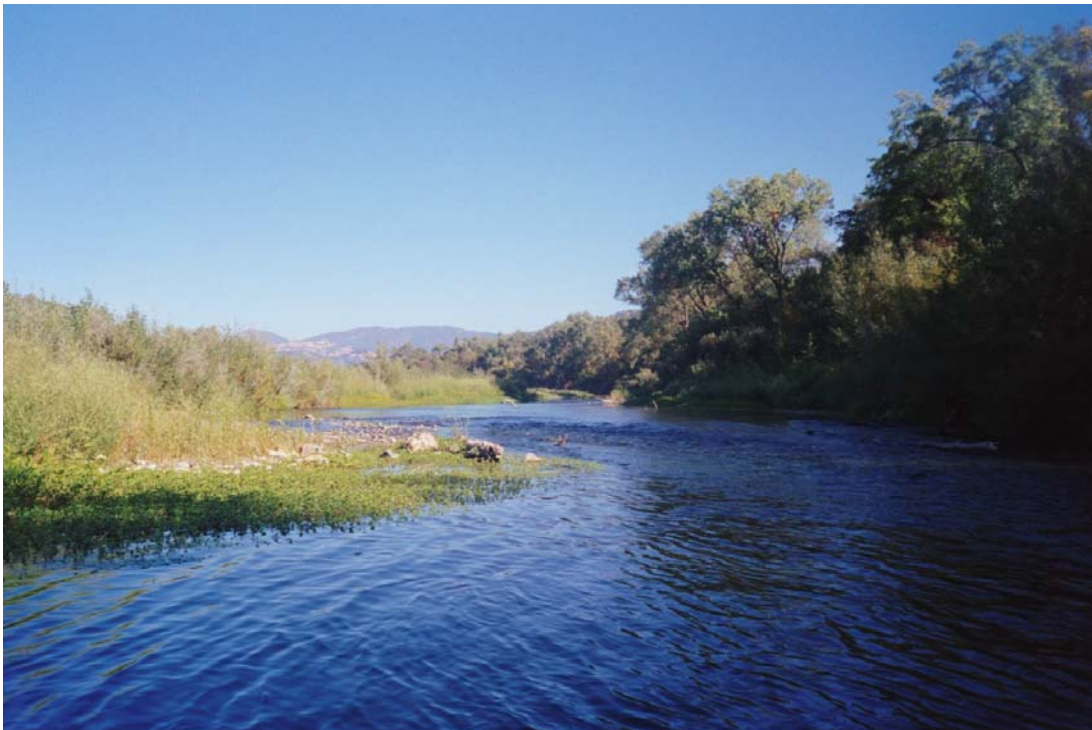
Figure 39: Healdsburg Reach, Segment H2. This segment contained mostly flatwater (94%) habitat with adjacent broad gravel bars, and occasional riffle (4%) and deep pool (2%) habitats. No steelhead were observed.

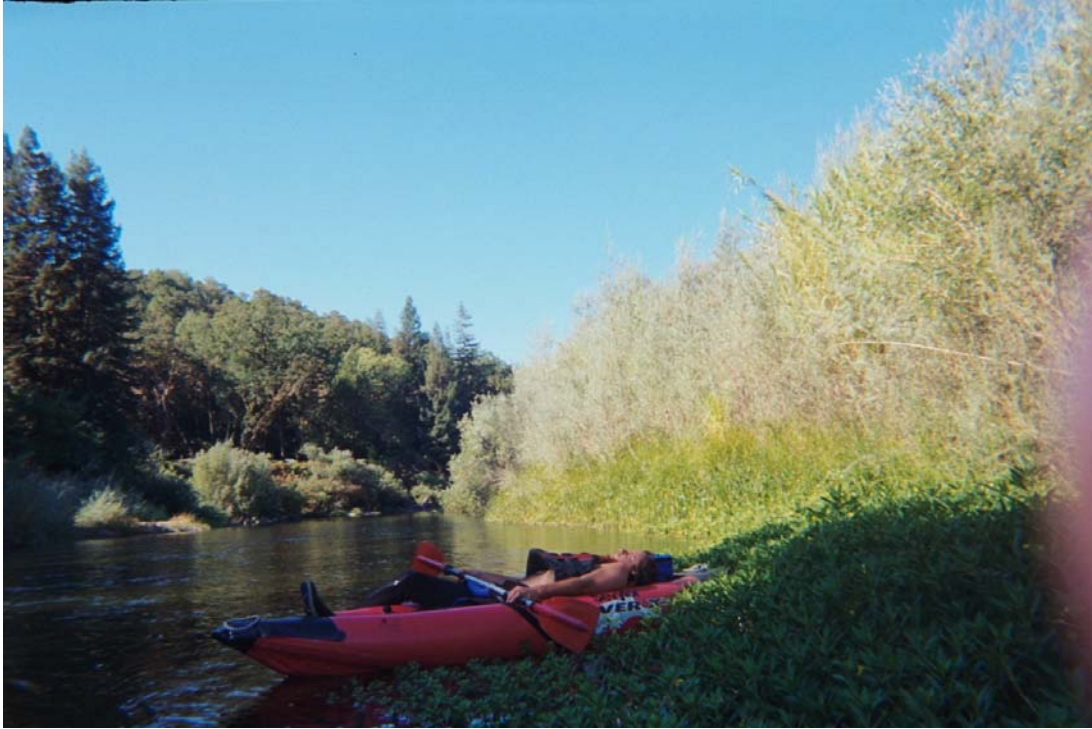
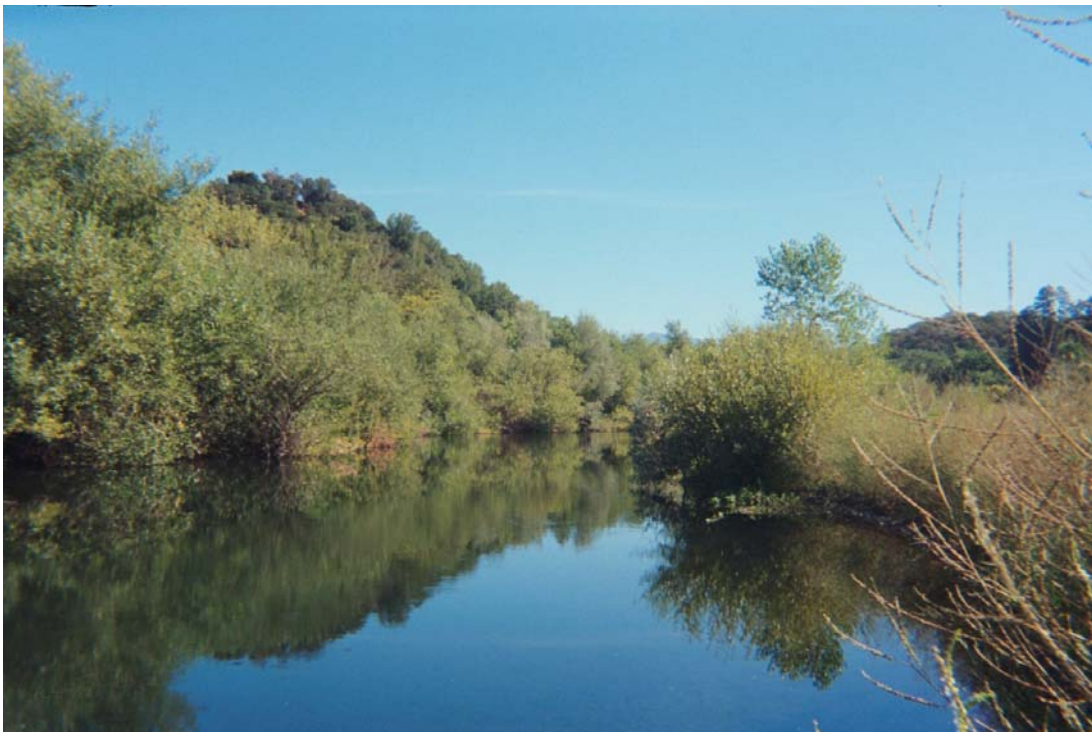
Figure 40: Healdsburg Reach, Segment H3. This segment contained flatwater (97%) and deep pool (3%) habitats. No steelhead were observed.

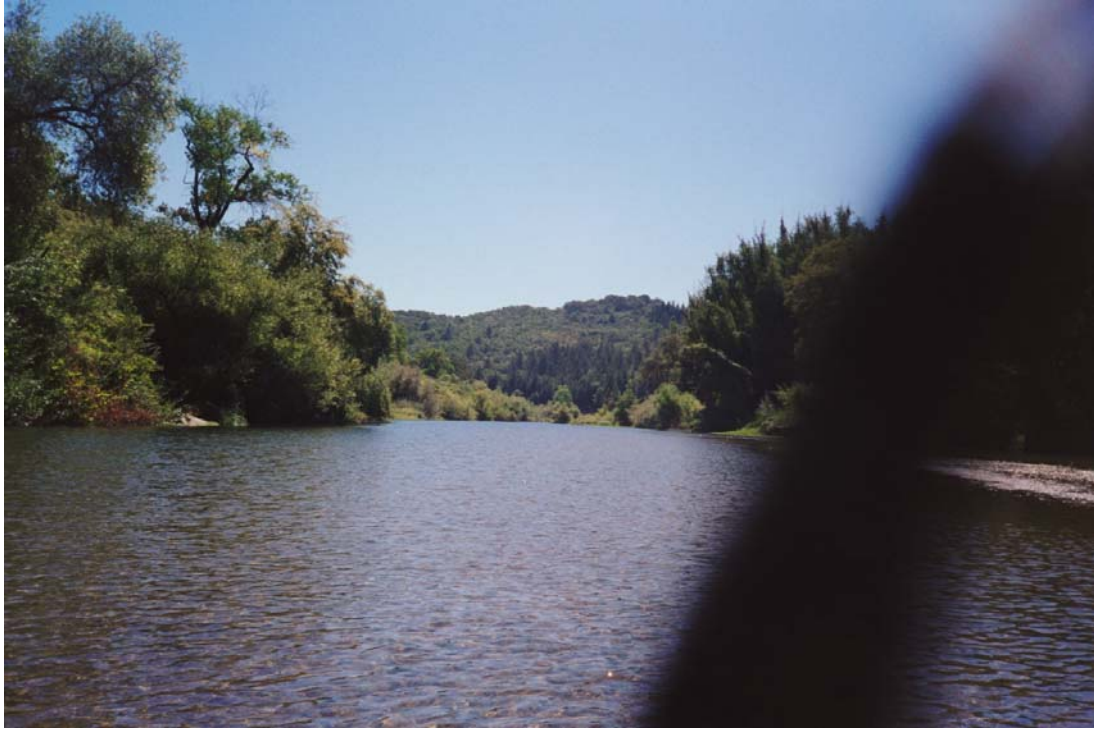
Figure 41: Healdsburg Reach, Segment H4. This segment was not dive surveyed but contained primarily flatwater habitat.
